# The Northwest Tropical Atlantic Station (NTAS): NTAS-2 Mooring Turnaround Cruise Report

September 2002

# **Technical Report**

## WHOI-2002-07 UOP-2002-04

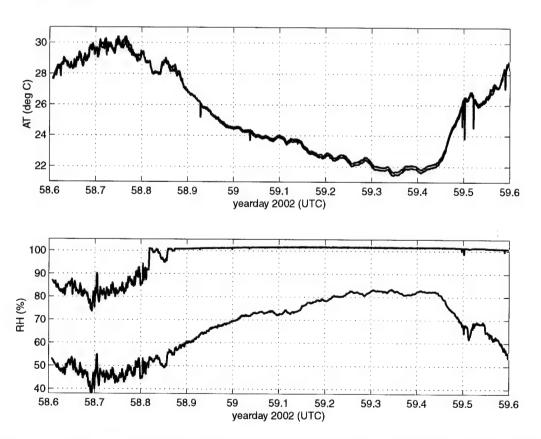
Continued testing, confirmation of the calibration constants, and comparison with hand-held sensors, led to the conclusion that the RH sensors of both HRH 225 and 227 were malfunctioning (AT performance was good). Visual inspection showed no obvious problems, and attempts to improve performance (e.g. by "drying out" the electronics with desiccant) were unsuccessful. It was decided that it would be necessary to recover the "good" HRH module from the NTAS-1 buoy (at sea), swap the flash card and EPROM with one of the "bad" NTAS-2 modules, and mount the refurbished NTAS-1 module on the NTAS-2 buoy.

Figure 13. Comparison of HRH SN 225 (red) and SN 226 (blue) during pre-cruise testing in Barbados. The AT sensors performed as expected, but SN 225 RH was about 30% higher than SN 226, and showed "saturation" when SN 226 was above about 60%.

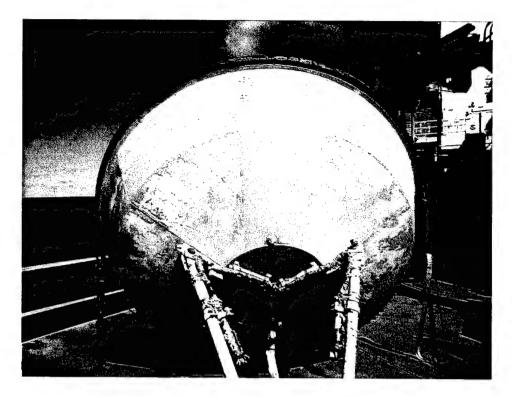
Figure 34. NTAS-1 discus buoy hull after recovery.

Fouling to protected regions of the buoy was localized on the bottom of the hull near where the bridle legs attach (Figure 35). The few gooseneck barnacles visible above were the only hard fouling organisms observed on the hull. Because these barnacles are clustered in protected regions of the hull, we assume that biological means of fouling control are keeping fouling in check where the antifouling paint has eroded away.

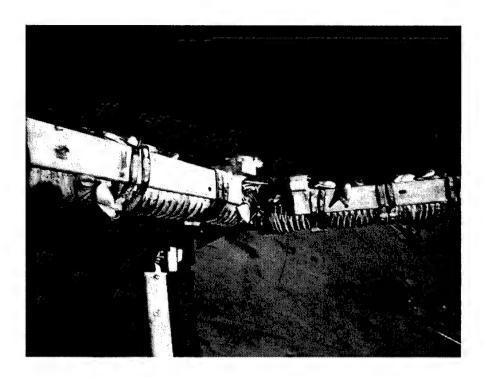
Figure 35. Gooseneck barnacle fouling on the NTAS-1 buoy hull.

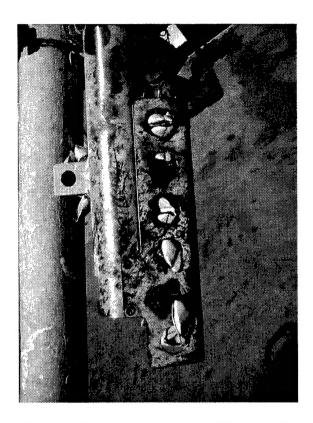
Most of the fouling observed was on instrumentation positioned near the surface. The SBE-37 MicroCATs attached to the bridle legs of the buoys at 2.1 m were the most heavily fouled instruments, especially around the sensor region of the instrument. Gooseneck barnacle fouling inside the guard that protects the sensor of the MicroCAT is visible in Figure 37. It is possible that this fouling caused one of the two MicroCAT instruments to give false temperature measurement due to the restriction of flow around the sensor.

Figure 37. Gooseneck barnacle fouling of MicroCAT sensor area.
